# SAN FRANCISCO PLANNING DEPARTMENT

## Historic Resource Evaluation Response

*Date:* May 29, 2015  
*Case No.:* 2014-003219ENV  
*Project Address:* 369 Valley Street  
*Zoning:* RH-2 (Residential-house, two family)  
40-X Height and Bulk District  
*Block/Lot:* 6620/033  
*Date of Review:* April, 2014 (Part I)  
*Staff Contact:* Justin Greving (Preservation Planner)  
(415) 575-9169  
justin.greving@sfgov.org

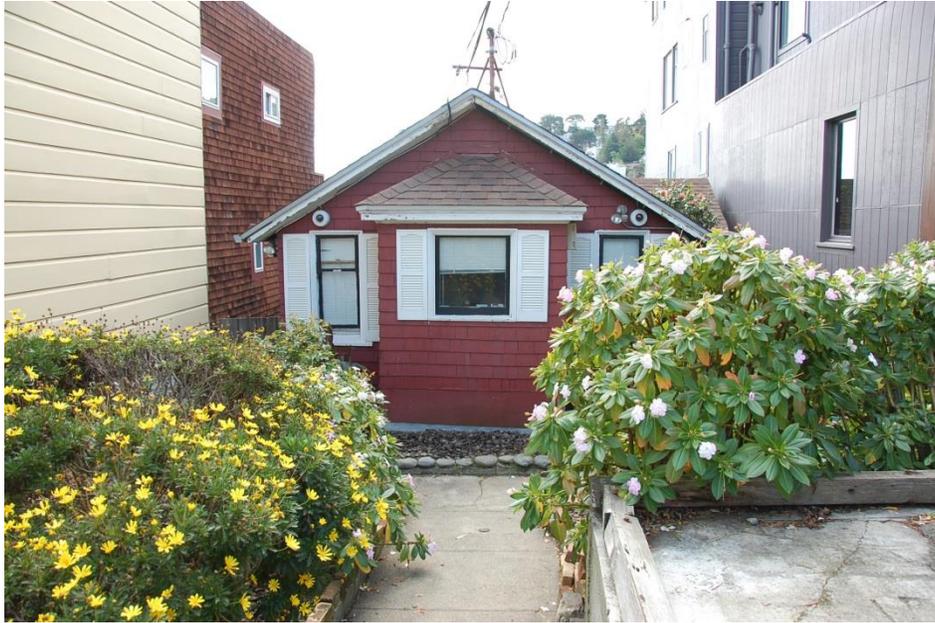
369 Valley Street, view S of primary (N) façade, (Planning Department)

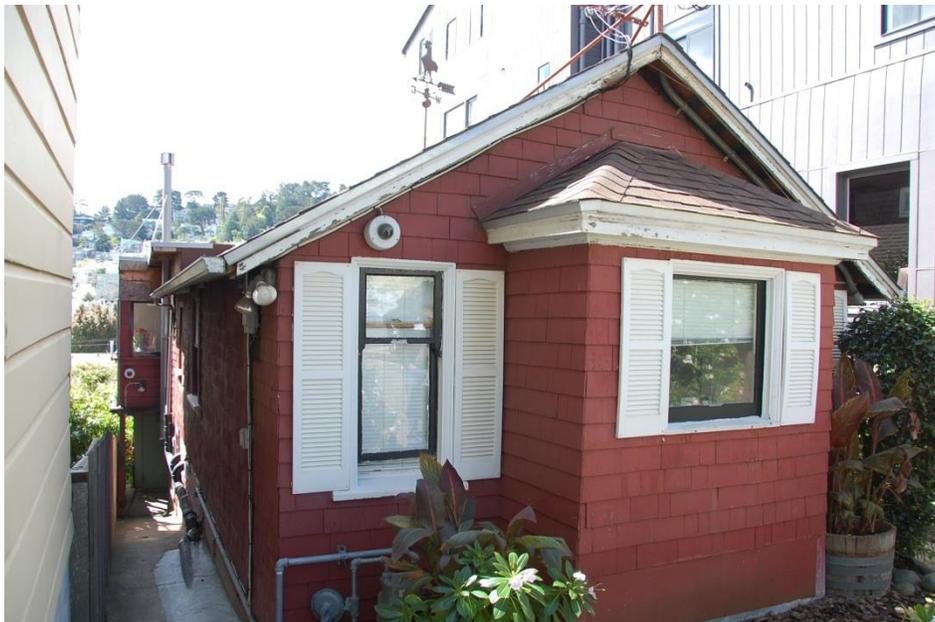
369 Valley Street, view SW of primary (N) façade, (Planning Department)

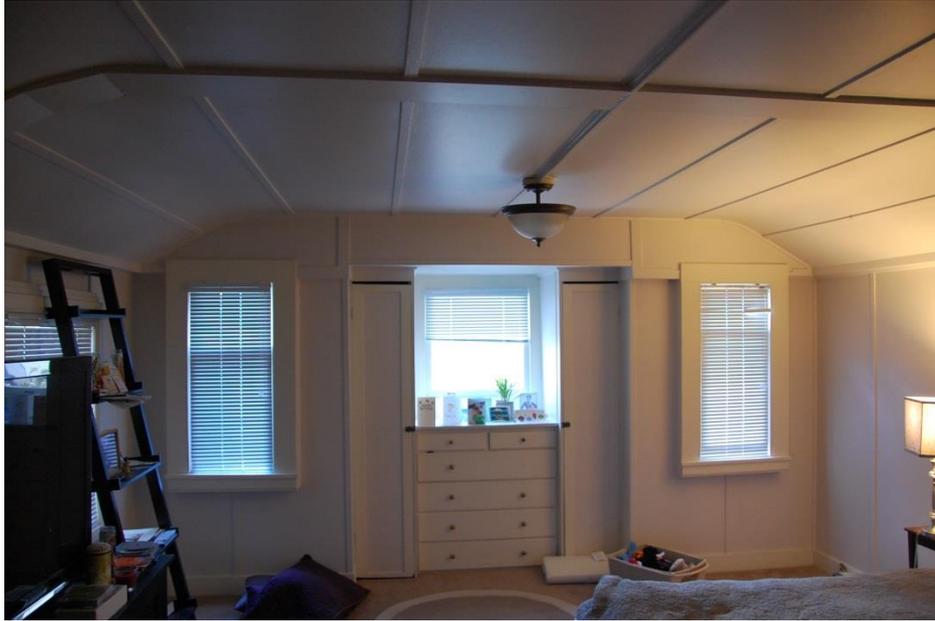
Interior view of 369 Valley Street showing covered ceiling, (Planning Department)

The workmanship most closely associated with the Earthquake Shacks relates to their simple construction methods and simplified forms. Certain characteristics on the interior, such as the coved ceiling, indicate the collar tie located half way up the roof truss is still intact and that other simplified methods of construction may also be embedded within the original structure. Although it is unclear what workmanship of these Earthquake Shacks remain, the simplified construction methods are likely intact underneath the early alterations.

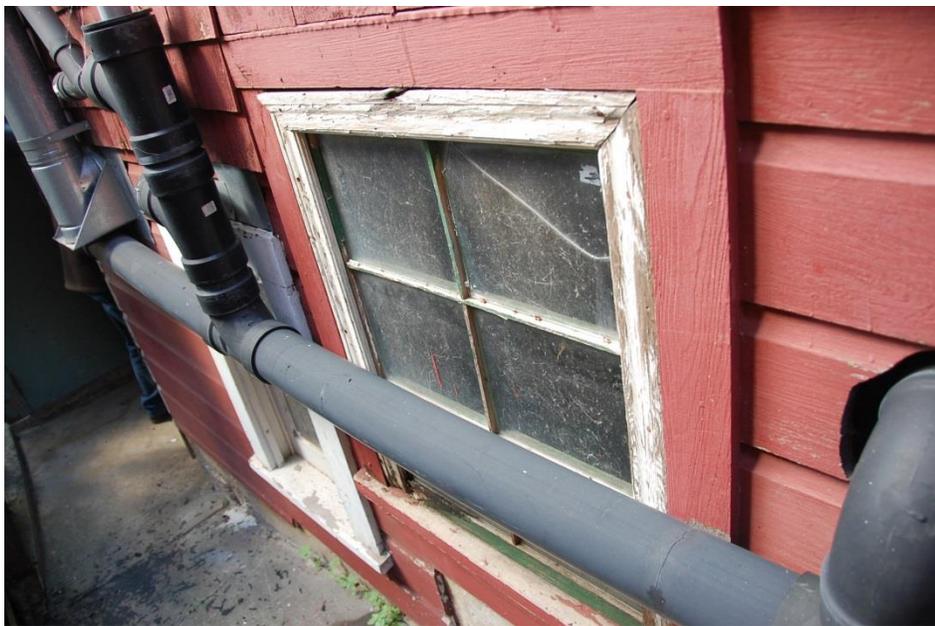
Exterior detail view showing salvaged original Earthquake Shack window (Planning Department)

modified. Earthquake Shacks originally featured a door and two windows below the peak of the gable as well as two windows on the opposite elevation. Shacks were constructed of vertical strips of redwood without additional exterior cladding. The subject property as it appears today from the street, with its altered entry sequence, boxed bay window, and shingle cladding, retains the original building footprint from as early as 1914 when it first appeared on the Sanborn map. Other minor details of note include a salvaged original 3x2 divided lite Earthquake Shack casement window located at the cripple wall along the east elevation.

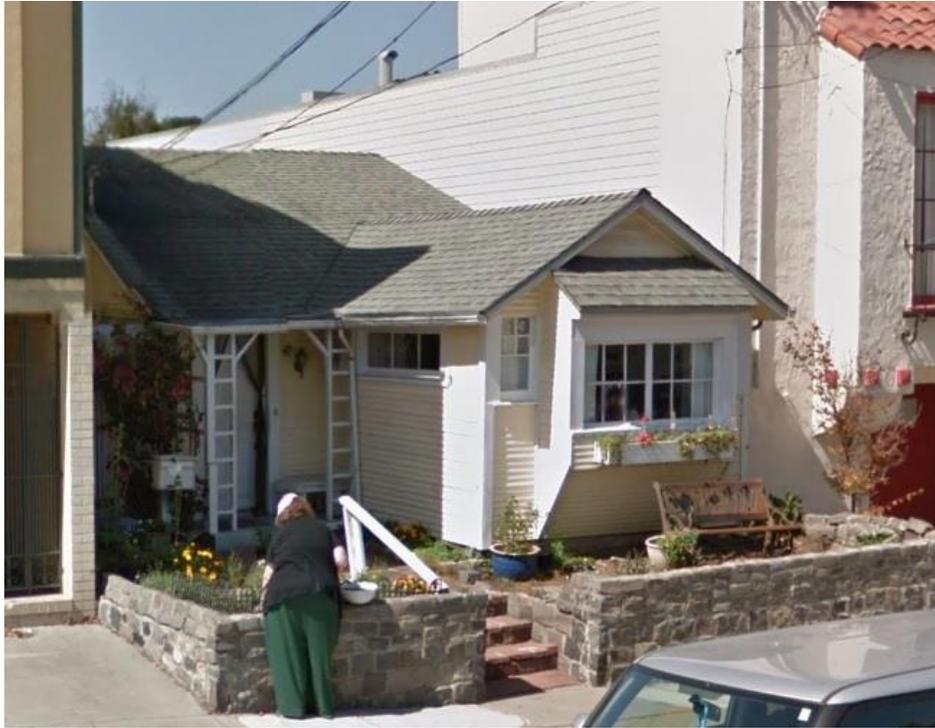
1227 24<sup>th</sup> Avenue is a compilation of 3 Type A shacks and is a designated local landmark (#171) (Google street view)

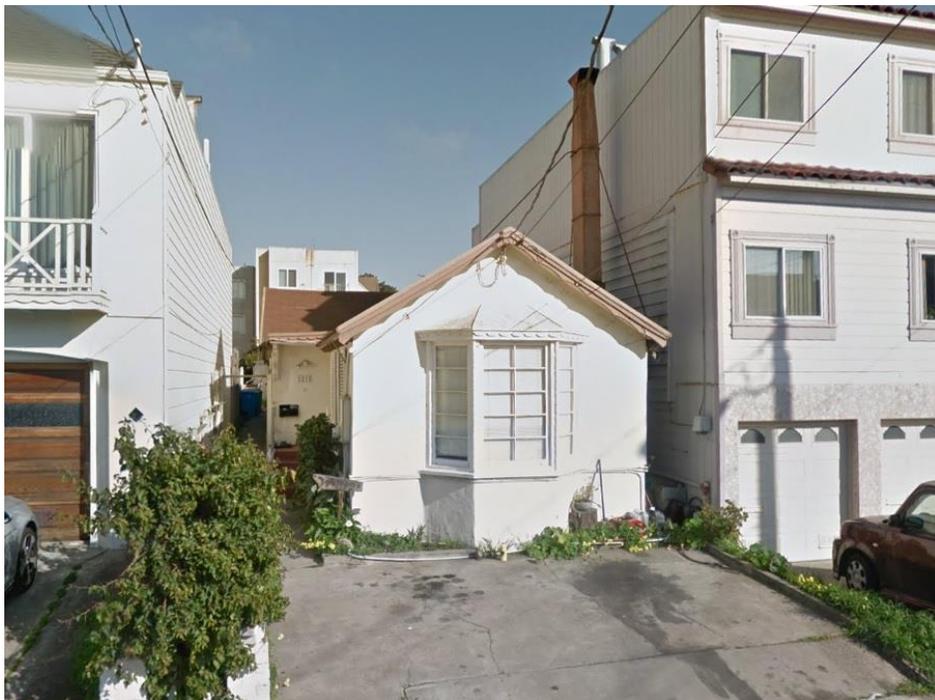
1218-1224 46<sup>th</sup> Avenue was surveyed in 2009 and identified as an Earthquake Shack eligible for listing in the California Register (Google street view)
